Study No. 4

Reliability of Transmission Lines and Feasibility of Eliminating Redundant Line

Mystic Lake Hydroelectric Project FERC No. 2301

PPL Montana

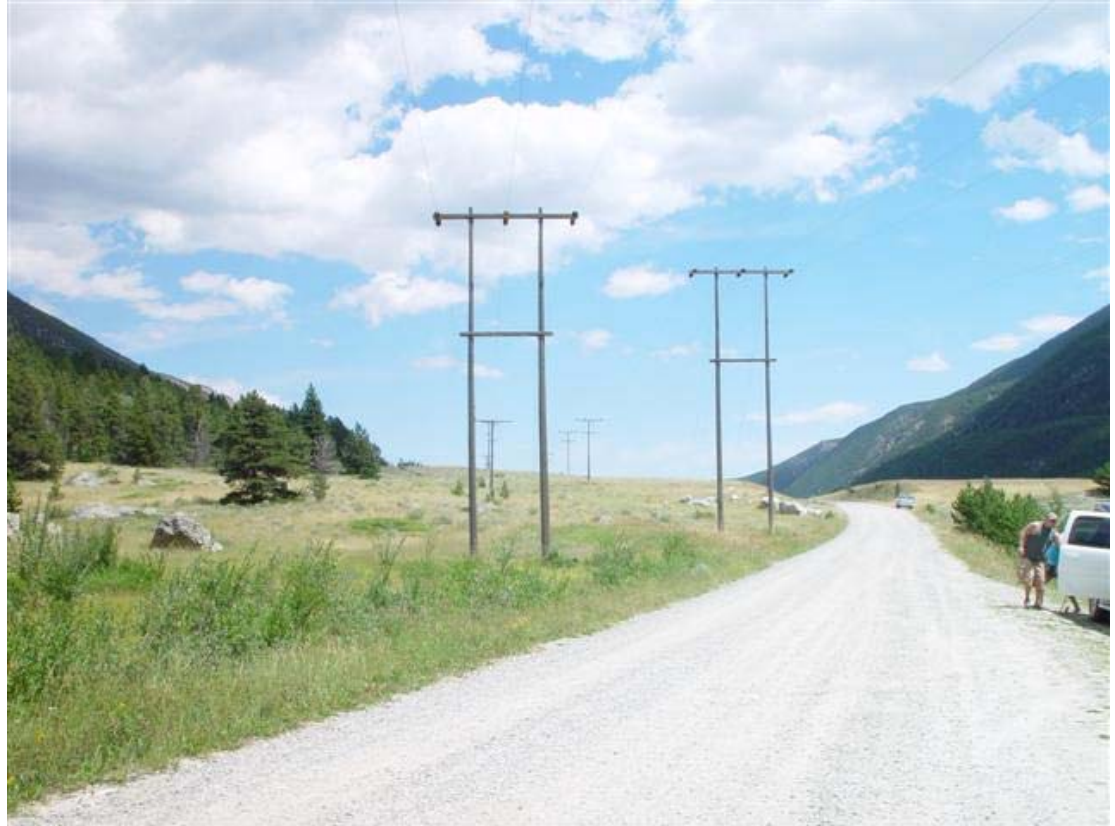
Figure 1. Mystic Lake Transmission Line near the West Rosebud Road.

The current two-line (A & B) system is 5.3 miles long and passes in tandem from the powerhouse to the Line Creek Substation along a route mostly parallel and in line of sight to the access road Figure 1. Near the powerhouse, the lines pass through lodgepole pine forest, each in a 50-foot wide T-Line ROW Corridor. This corridor is actually not sufficiently wide to prevent tree strikes from shorting the electrical lines and causing outages. Previous requests from PPL Montana to widen the ROW corridor to reduce tree impacts have met with reluctance by USFS for environmental reasons (personal communications, PPL Montana).

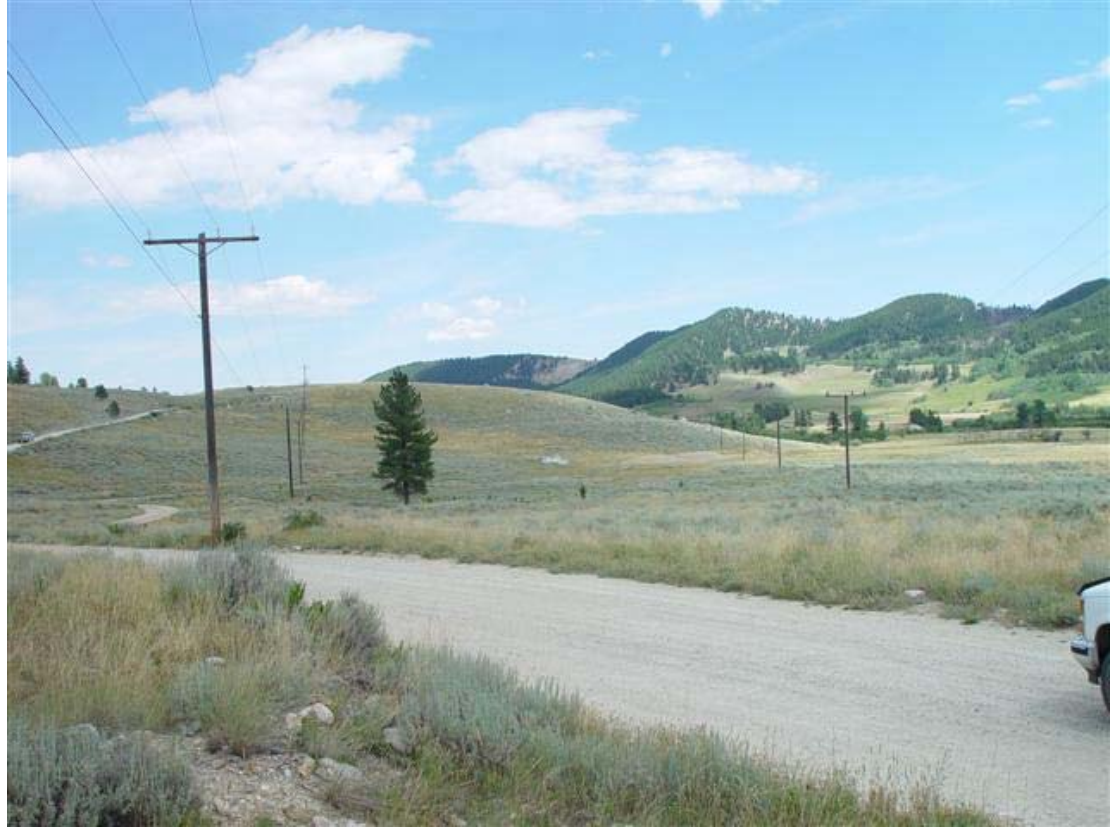
Figure 2. Shows the A and B lines.

The electrical connection of Mystic Lake Powerhouse to the Line Creek Substation consists of two separate and redundant lines, named A and B (Figures 1 – 4). Both carry power continuously and join the grid at the Line Creek Substation, approximately 5 miles from the powerhouse along West Rosebud Road. Individually each has capacity to carry the full load of Mystic Lake Powerhouse should one line encounter an outage. This redundancy was built into the system early in the history of the project because outages were common. The transmission line can be interrupted by severe weather, snow avalanches, lightning strikes and shorts due to trees, physical deterioration, or other unpredictable events. A complete outage has two severe consequences: (1) loss of energy from Mystic Lake with a series of emergency actions that must take place and (2) destabilization of the power supply to the Stillwater Mine, an important electricity customer that relies on the reliability provided by the A and B lines at Line Creek Substation.

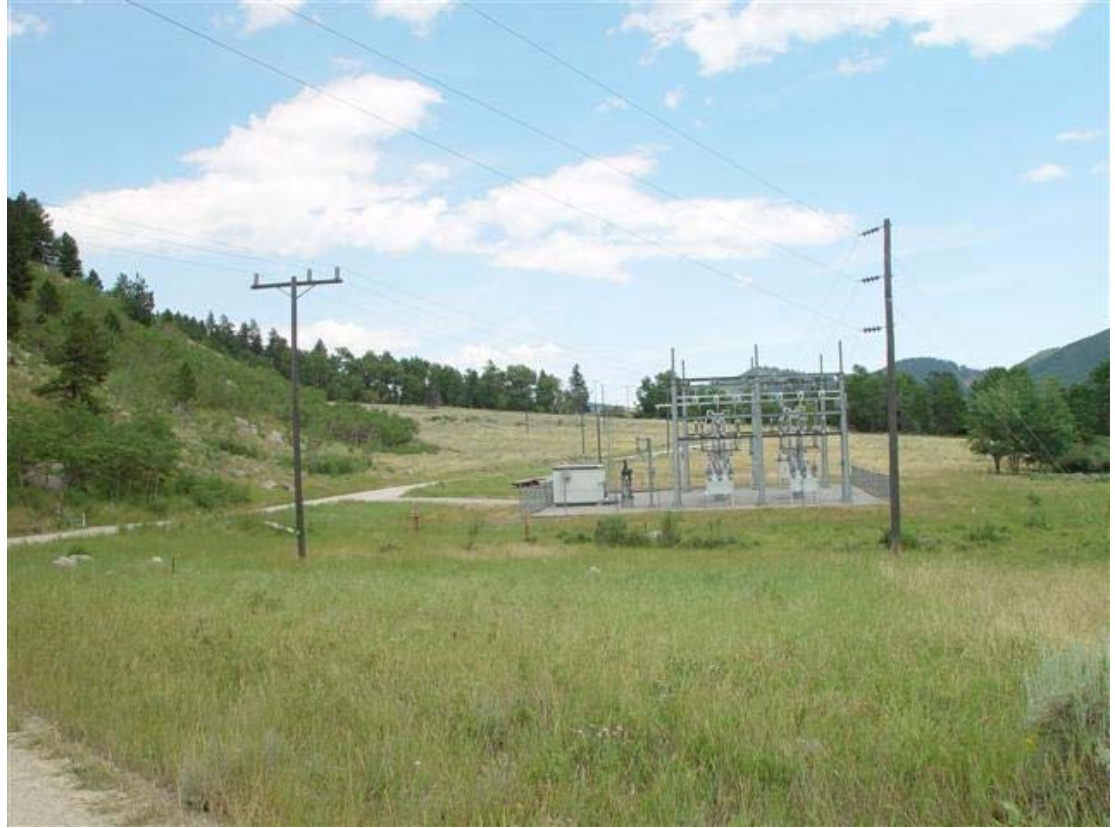
Figure 3. Line Creek Substation

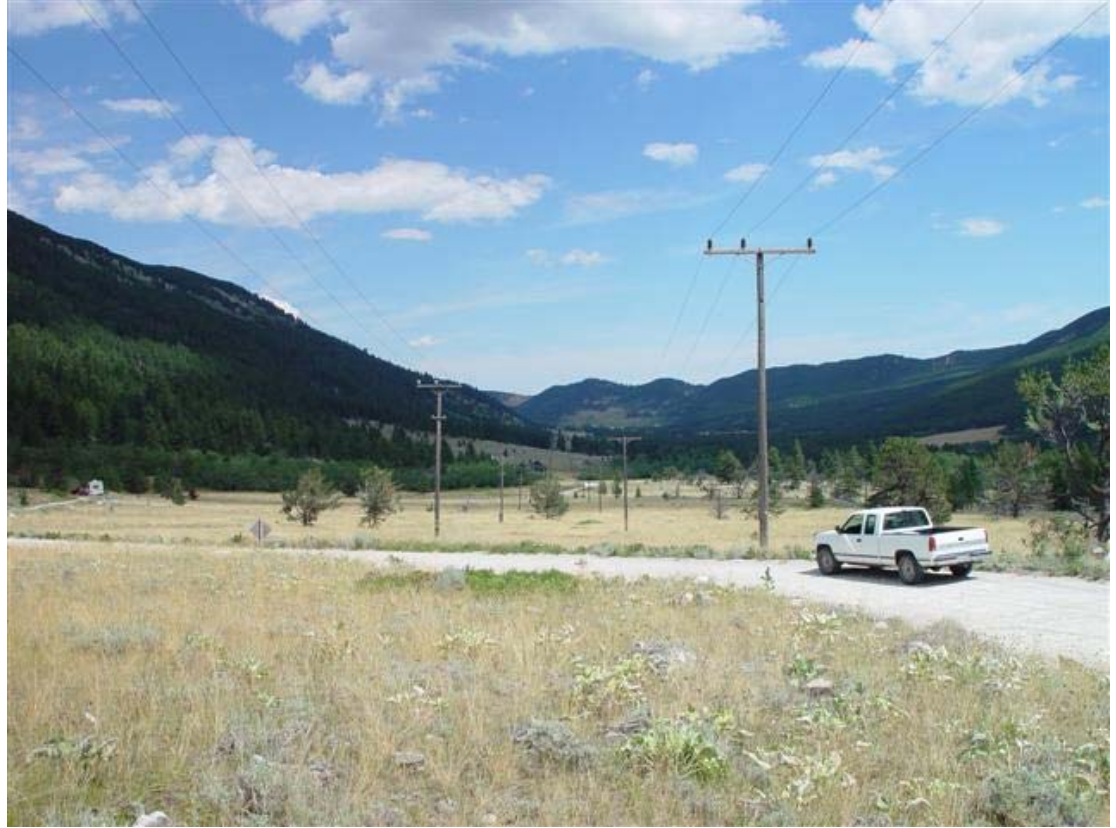
Figure 4. Another view of the A and B lines.
